INDOOR AIR QUALITY ASSESSMENT

**North/Central House
Burkland Intermediate/Goode Elementary School Complex
41 Mayflower Avenue
Middleborough, Massachusetts**

Prepared by:
Massachusetts Department of Public Health
Center for Environmental Health
Bureau of Environmental Health Assessment
Emergency Response/Indoor Air Quality
January 2005

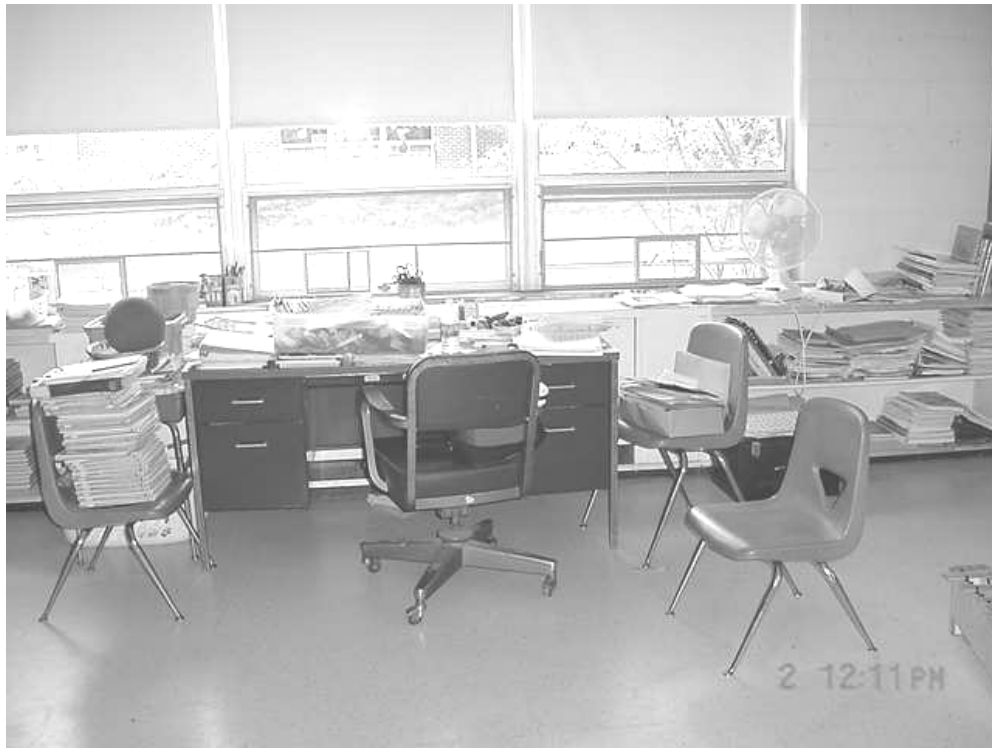
Picture 1

assessment (Table 1). Obstructions to airflow, such as papers and books stored on univents and items placed in front of univent returns, were seen in a number of classrooms (Picture 1). In order for univents and supply vents to provide fresh air as designed, these units must remain activated and allowed to operate while rooms are occupied. In addition, univent intakes and diffusers must remain free of obstructions.

Univent Return Vent Obstructed by Desk

6. Remove all blockages from univents and exhaust vents to facilitate airflow.
7. Consider balancing mechanical ventilation systems every 5 years, as recommended by ventilation industrial standards (SMACNA, 1994).

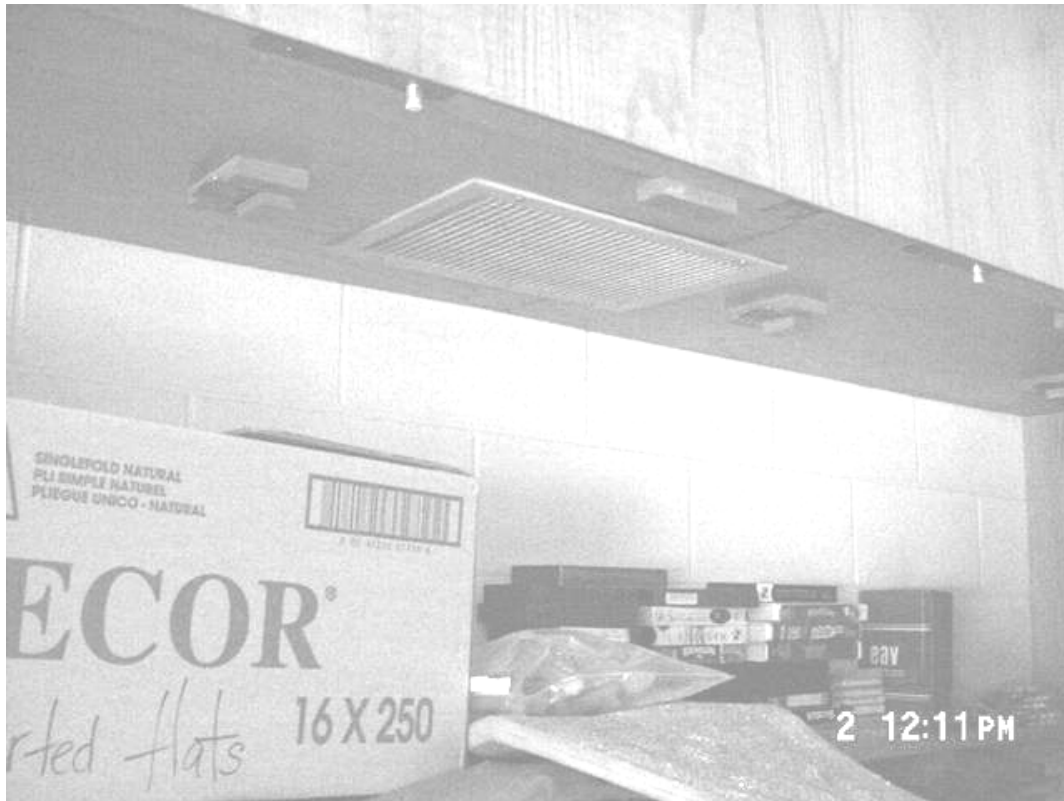
Picture 2

Mechanical exhaust ventilation is powered by rooftop fans. Exhaust vent grilles are located in the ceilings of coat closets (Picture 2) or in classroom walls. Air is drawn into the classroom coat closet via undercut closet doors. The exhaust system was not drawing in a few areas, indicating that motors had either been deactivated or were non-functional (Table 1). The location of these closet vents allows them to be easily blocked by stored materials, which restricts airflow. As with the univents, exhaust vents must be activated and remain free of obstructions in order to function as designed. Without sufficient supply and exhaust ventilation, environmental pollutants can build up, leading to indoor air quality complaints.

Coat Closet Exhaust Vent

4. Contact an HVAC engineering-firm to inspect and/or make repairs to the pool AHU.
5. Inspect rooftop exhaust motors and belts for proper function, repair and replace as necessary.

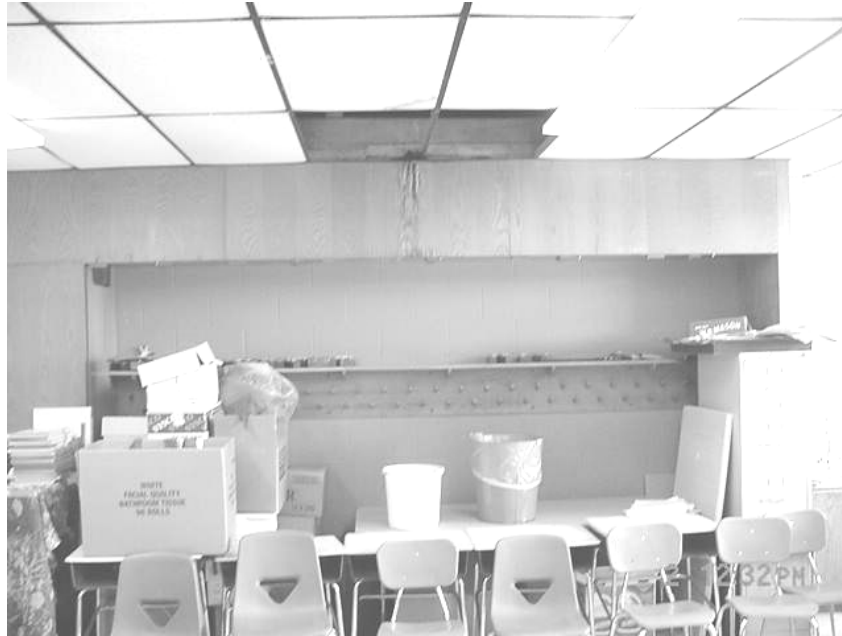
Picture 3

At the time of the assessment, school department officials reported that the building had active roof leaks and that funding for roof repair was part of a planned capital repair project. Water damaged ceiling tiles were observed in a number of areas throughout the building. Water-damaged ceiling tiles can provide a source of mold growth and should be replaced after a water leak is discovered and repaired. Buckets were observed to have been

placed in areas to “catch” rainwater in classroom 51 (Picture 3). Water damaged wood was observed in this area with what appeared to be mold growth (Picture 4).

Missing/Damaged Ceiling Tiles and Buckets Catching Rainwater in Classroom 51

10. Continue with plans for roof repair/replacement. Replace any water-damaged ceiling tiles, once leaks are repaired. Examine the area above and beneath these areas for

microbial growth. Disinfect areas of water leaks with an appropriate antimicrobial.
Clean areas of antimicrobial application when dry.

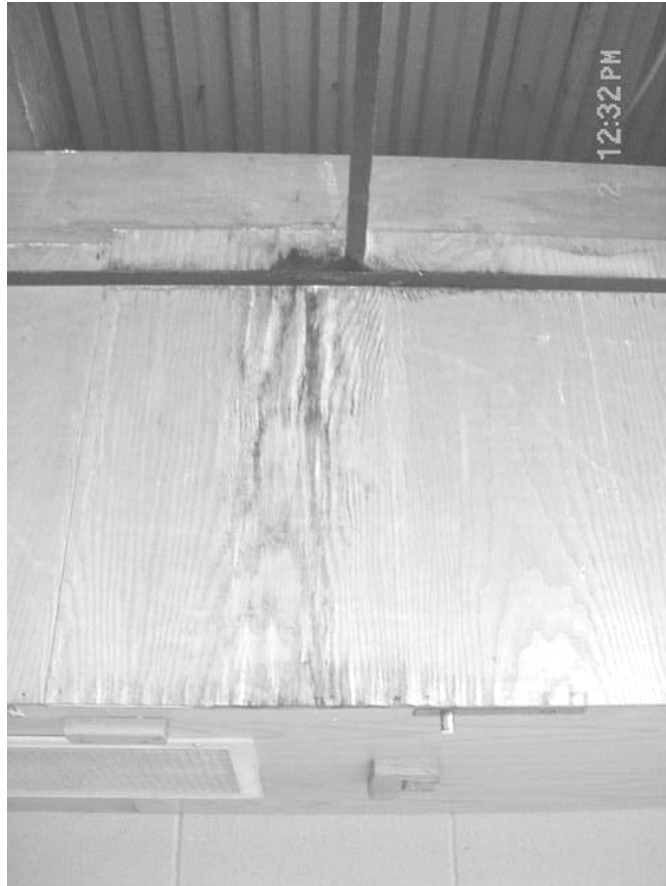
Picture 4

Close Up of Water Damaged Wood, Dark Spots Indicate Possible Mold Growth

9. Remove water damaged/mold contaminated wood work in classroom 51. Mold contaminated materials should be removed in a manner consistent with recommendations found in “Mold Remediation in Schools and Commercial Buildings” published by the US EPA (US EPA, 2001). The document is available at the US EPA website at: http://www.epa.gov/iaq/molds/mold_remediation.html.
